**Flood Control Project Maintenance
Levee Inspections**
LMA District Cover Sheet
Spring 2018 Levee Inspection Results

Reclamation District No. 0070 Meridian

Spring 2018 Levee Inspection Results

Waterway			Bank	Unit Miles
Unit No. 01 Sutter Bypass			Right	7.92
	Spring (March - May)	Summer (June - August)	(September - November) Fall	Winter (December - February)
Unit Maintenance Rating (Fall Only)				
Date of Inspection	3/15/2018 - 3/15/2018			
DWR Inspector	Bob Duffey			
Accompanied By	Andy Duffey

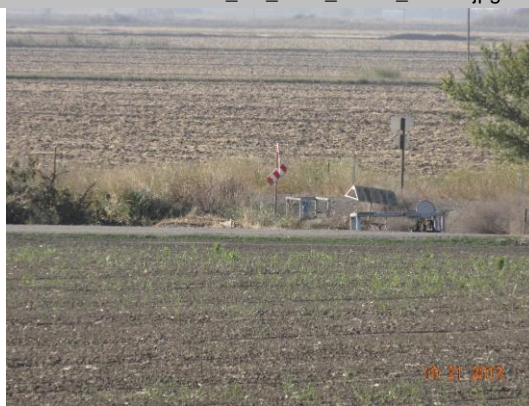
Photo 3 of 3 : UCIP_SP_2018_23463_40620.jpg

Comment Code					
Inspector Comment					
FS_ID:23463 DS_ID:21347 EP_NO: 3804 Repair Type: Non-Urgent Crossing Status: Indicator Found UCIP Comments: Unable to confirm if the indicators that were found in the field correspond to this crossing. Will need to contact PG&E to confirm location of crossing. Photos will need to be updated if the photos attach do not correspond to this crossing. This crossing is referenced in the USACE Periodic Inspection as item USACE_CESPK_MRD1_2012_p_0304 for 12 inch gas pipe. Coordinates between DWR UCIP and USACE PI are approximately 630 feet apart. FIELD_STRUCT_DESC: 12-inch coated steel natural gas pipeline through the levee, 3.6 feet below the crown. Concrete cutoff wall around the pipe at the center of the levee. Marker sign on the waterside (WS) shoulder. Rock revetment on the WS slope. (Plans for installation of a 12-inch gas collecting line through the levee authorized under Permit No. 3804, 1961 - Pacific Gas and Electric Company [PG&E]). [Additional Reference(s): DWR Levee Log, 2007]. FS Date: 10/21/2013

View of gas line markers approximately 900 feet away.

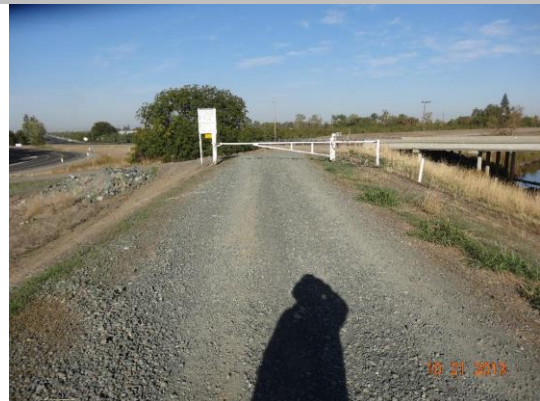
Photo 2 of 3 : UCIP_SP_2018_23503_40780.jpg

View of levee crown looking downstream.

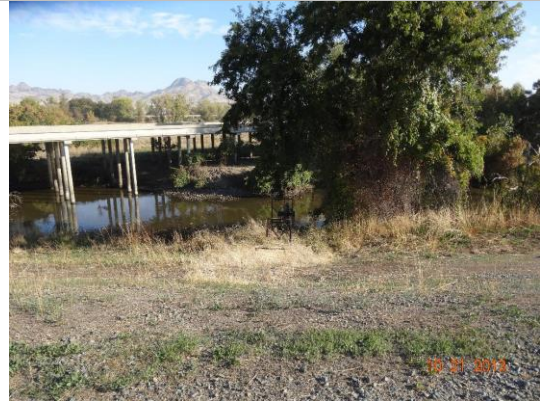
Photo 3 of 3 : UCIP_SP_2018_23503_40785.jpg

Comment Code						
Inspector Comment						
FS_ID:23503 DS_ID:21351 EP_NO: 3686 Repair Type: Non-Urgent Crossing Status: Found UCIP Comments: Dense vegetation limits the inspector's visibility to identify signs of pipe failure (leaks) along the waterward slope. Recommend removing vegetation along pipe alignment to conduct proper inspection of structure and appurtenances. Unable to find the gate valve on landward side. Walkway on waterward side in bad shape. This crossing is referenced in the USACE Periodic Inspection as item USACE_CESPK_MRD1_2012_p_0300 for 18 inch pipe. Pipe on LS is 10 inch not 18 inch. SEE UCIP DS_ID 21350 for details pertaining to 18 inch pipe. FIELD_STRUCT_DESC: 10-inch irrigation discharge pipe of an unknown material through the levee, 14.8 feet below the crown. Electrical conduit through the levee, 1 foot below the crown. Pump on a pile structure in the stream. Service pole with meter and control panel at the landside (LS) toe. Slide gate with walkway on the waterside (WS) end. Gate valve on the LS end, not found during 10/21/2013 pipe inventory. Rock revetment on the WS slope. (Plans for removal of a pump on the LS and installation of a pump and two concrete piers on the WS authorized under Permit No. 3686, 1961 - Gerald A. Frye). [Additional Reference(s): DWR Levee Log, 2007]. FS Date: 10/21/2013

View of waterward side--dense vegetation along slope.

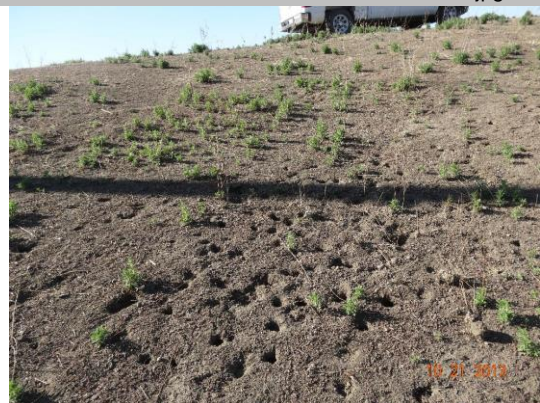
Photo 2 of 3 : UCIP_SP_2018_23508_40819.jpg

Dense burrow activity found on waterward slope.

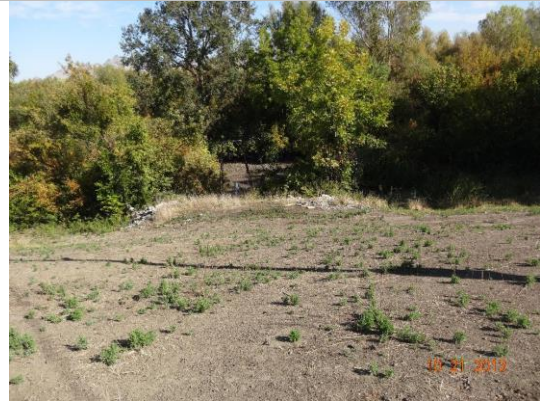
Photo 3 of 3 : UCIP_SP_2018_23508_40820.jpg

Comment Code						
Inspector Comment						
FS_ID:23508 DS_ID:21336 EP_NO: N/A Repair Type: Non-Urgent Crossing Status: Found UCIP Comments: Need to find owner to determine if crossing is still in use. If crossing is no longer in use owner will need to coordinate with DWR inspector and CVFPB to remove according to Title 23 requirements. Evidence of high burrow activity on waterward side recommend addressing issue. This crossing is referenced as USACE_CESPK_MRD1_2012_p_0230 in the USACE's PI report for no USACE recommendation letter available -- correction pipe is 12-inch not 16-inch. FIELD_STRUCT_DESC: 12-inch irrigation discharge pipe of an unknown material through the levee, 4 feet below the crown. Siphon breaker on the landside (LS) slope. 7-foot by 9-foot concrete distribution box at the LS toe. Service pole on the waterside (WS) slope. Pump on a concrete sump on the WS slope. Overhead power line crosses the levee. (Plans for the installation of a 12-inch steel irrigation pipe through the levee authorized under Permit No. 613, 1934 - Waldo M. Nall. Plans to retain a 12-inch pipe through the levee, 4 feet below the crown, pump, and siphon breaker authorized under Automatic Board Order (ABO) issued as Permit No. 9948, 1974 - Edward E. and Doris M. Nall). [Additional Reference(s): DWR Levee Log, 2007]. FS Date: 10/21/2013

View of waterward side.

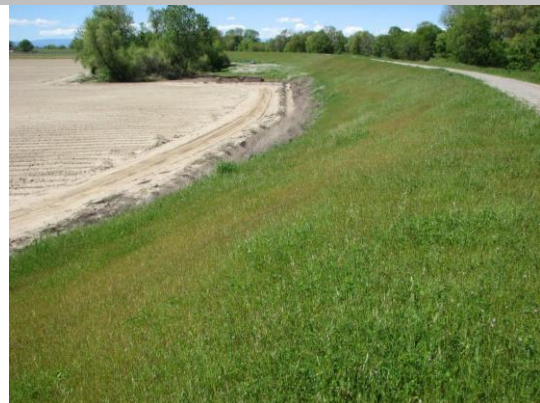
Photo 1 of 1 : SP_2018_RD0070_29_27_20180305_00003.jpg

LM Start	2.74	Rating **	M	Issue No.	27
LM End	2.82	Issue Type +	En	Location *	LS
Category	Earthen Levee			GPS Latitude/Longitude	
				Start	End
Item	Encroachments			39.157741 °	39.158135 °
				-121.871588 °	-121.872979 °
DWR ID	DWR_RD0070_01_s_2016_27				
Comment Code					
DT : Ditch					
Inspector Comment

Concrete ditch at landside toe.

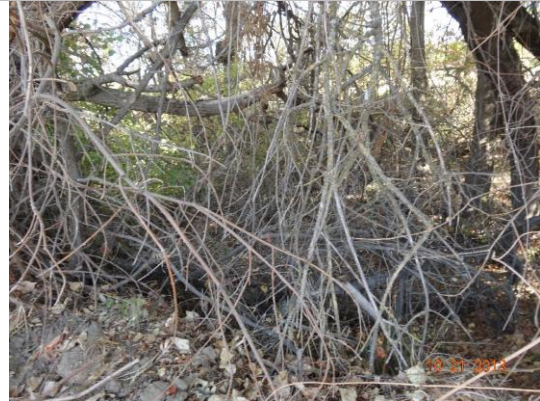
Photo 3 of 3 : UCIP_SP_2018_23530_40971.jpg

Comment Code					
Inspector Comment					
FS_ID:23530 DS_ID:21322 EP_NO: N/A Repair Type: Non-Urgent Crossing Status: Indicator Found UCIP Comments: Unable to determine if crossing exists need to coordinate with LMA to determine if more information is available about crossing. This crossing is referenced in the USACE Periodic Inspection as item USACE_CESPK_MRD1_2012_p_0208 for concrete ditch lined within 15 feet of LS toe, no water present, and no USACE recommendation letter available. FIELD_STRUCT_DESC: 12-inch steel irrigation discharge pipe through the levee, at an unknown depth. Cutoff wall around the pipe at the center of the levee. Slide gate on each end. Pump on the waterside (WS). Concrete distribution box on the landside (LS). [Additional Reference(s): USACE Sacramento O&M Manual 134, June 1953, (Station 142+70)]. FS Date: 10/21/2013

Waterward side covered by vegetation.

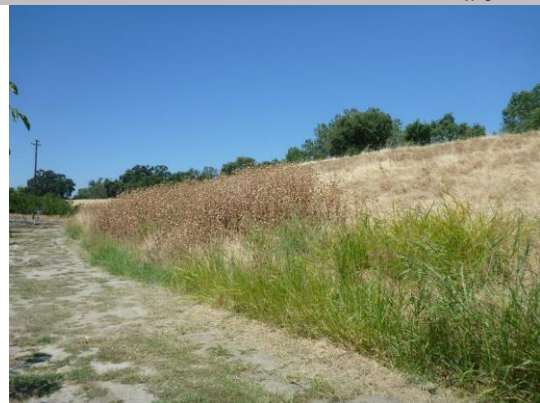
Photo 1 of 3 : LEVAL_SP_2018_153_1702.jpg

LM Start	3.18	Rating **	A/W	Issue No.	37	
LM End	3.18	Issue Type +	Ob	Location *		
Category	Supplemental			GPS Latitude/Longitude		
				Start	End	
Item	2017 Storm Damage			39.157480 °	39.157480 °	
				-121.879250 °	-121.879250 °	
DWR ID	DWR_RD0070_01_f_2017_37					
Comment Code						
Inspector Comment						
Levee Evaluation Comments						
Description:						
Site ID No:153						
Site Designation:RD 70-02						
Repair Type: Seepage (B)						
Rating:Serious						
Field Date:7/17/2017						
Notes:

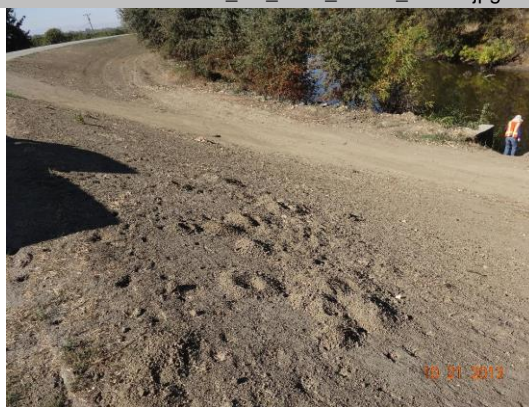
Photo 2 of 3 : UCIP_SP_2018_23506_40801.jpg

FS_ID:23506
DS_ID:21361
EP_NO: 9944
Repair Type: Non-Urgent
Crossing Status: Found
UCIP Comments: Burrow activity present on levee slopes. Multiple pipes found on landward side--are these pipes part of original crossing? This crossing is referenced in the USACE Periodic Inspection as item USACE_CESPK_MRD1_2012_p_0291--no USACE recommendation letter available.
FIELD_STRUCT_DESC: 18-inch steel irrigation discharge pipe through the levee, 21.5 feet below the crown. Gate valve on the waterside (WS) end. Pipe discharges into a concrete box on the landside (LS). Rock revetment on the WS slope. (Retention of an 18-inch steel pipe through the levee, 21.5 feet below the crown, gate valve, and concrete box authorized under Automatic Board Order (ABO) issued as Permit No. 9944, 1974 - William J. and Marion D. Hankins). [Additional Reference(s): DWR Levee Log, 2007].
FS Date: 10/21/2013

Recent burrow activity soil months next to holes.

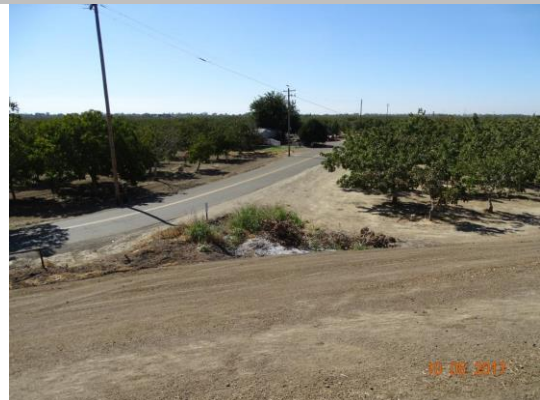
Photo 1 of 2 : SP_2018_RD0070_29_30_20180305_00005.jpg

View of the prunings along the landside toe.

LM Start	4.65	Rating **	M	Issue No.	30
LM End	4.65	Issue Type +	En	Location *	LS
Category	Earthen Levee			GPS Latitude/Longitude	
				Start	End
Item	Encroachments			39.168110 °	39.168110 °
				-121.899910 °	-121.899910 °
DWR ID	DWR_RD0070_01_f_2016_30				
Comment Code					
PR : Prunings					
Inspector Comment					
Remove the prunings from the landside slope.

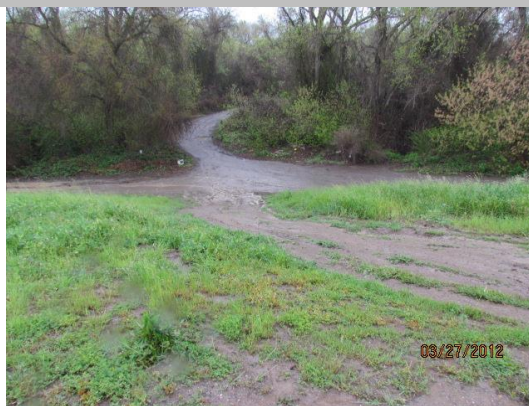
Photo 1 of 2 : SP_2018_RD0070_29_6_20180305_00001.jpg

View of vehicle erosion along the waterside slope.

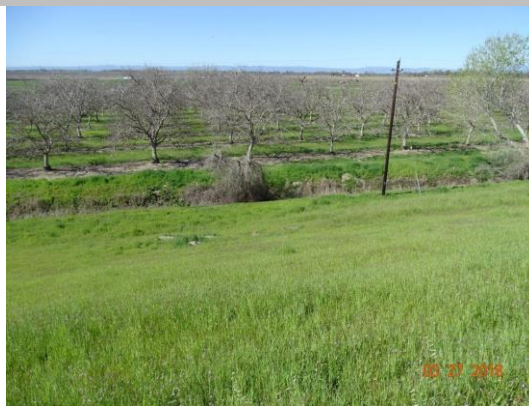
Photo 1 of 1 : SP_2018_RD0070_29_35_20180403_00076.jpg

View of the rodent holes along the landside slope.

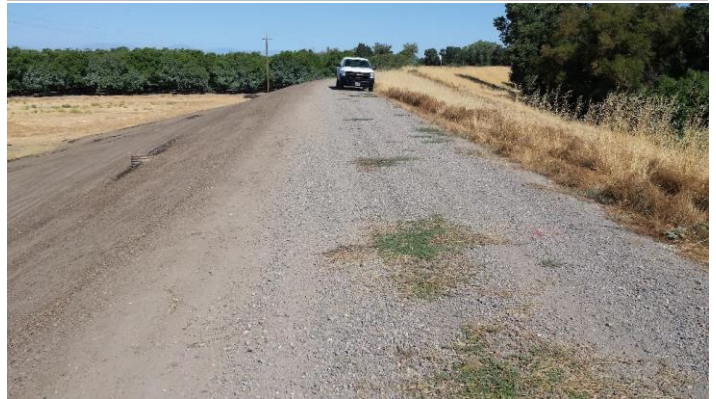
Photo 1 of 3 : UCIP_SP_2018_46422_74619.jpg

Overview of levee crown at crossing. No change from last inspection.

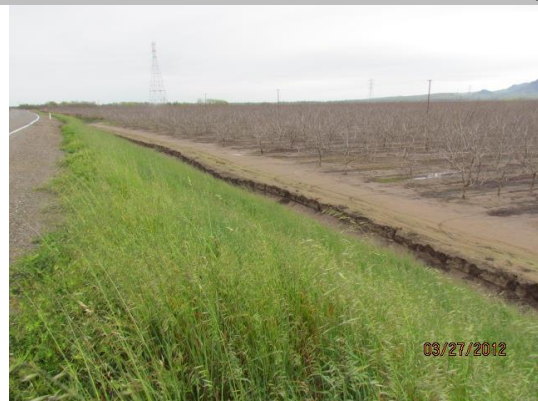
Photo 1 of 1 : SP_2018_RD0070_30_1_20180305_00001.jpg

Agricultural ditch along the landside toe.

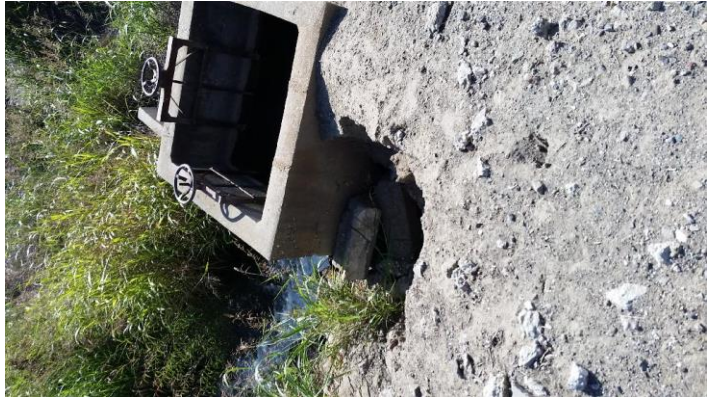
Photo 3 of 3 : UCIP_SP_2018_52551_75306.jpg

Scour hole has progressed since 2015.

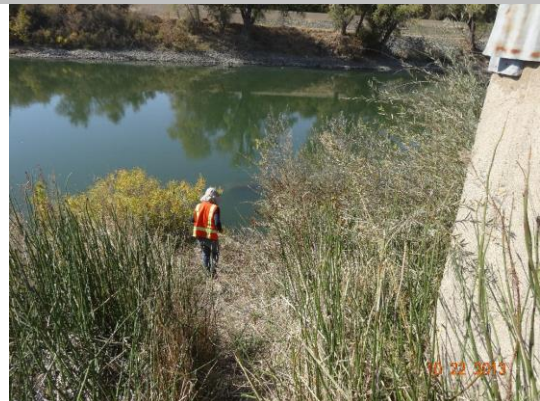
Photo 3 of 3 : UCIP_SP_2018_23891_41837.jpg

Dense vegetation covers pipe intake on waterward side.

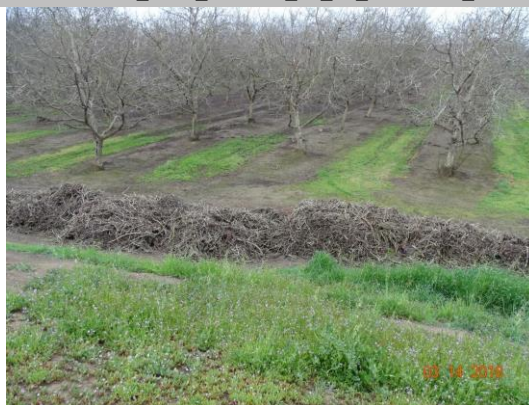
Photo 1 of 1 : SP_2018_RD0070_30_47_20180402_00125.jpg

View of the prunings along the landside toe.

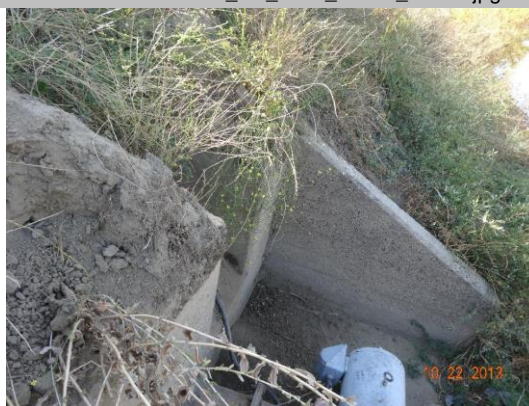
Photo 3 of 3 : UCIP_SP_2018_23964_42113.jpg

Crossing appears altered on waterward side.

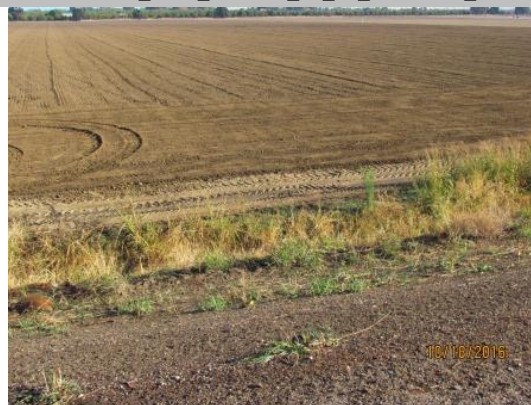
Photo 1 of 1 : SP_2018_RD0070_30_56_20180305_00007.jpg

View of a ditch at the landside toe.

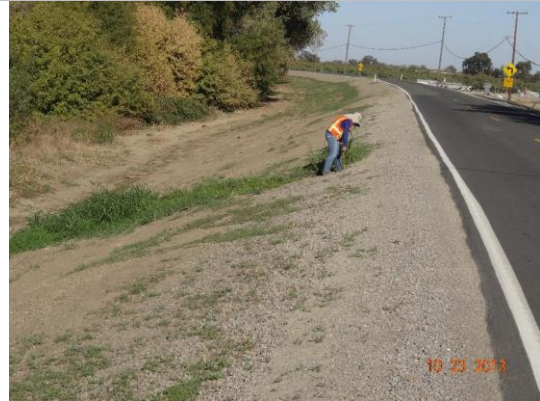
Photo 1 of 3 : UCIP_SP_2018_50007_42684.jpg

Vegetation on WS where leak found.

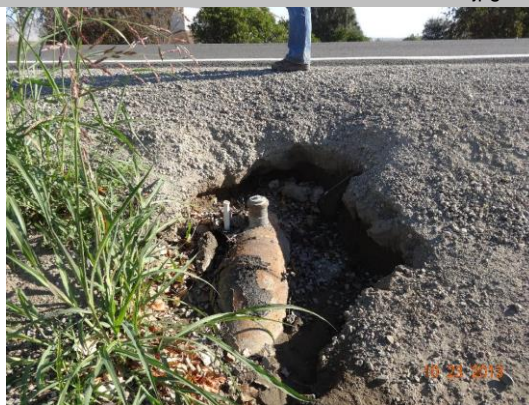
Photo 2 of 3 : UCIP_SP_2018_50007_42680.jpg

Damage to WS shoulder due to leaky pipe or siphon breaker.

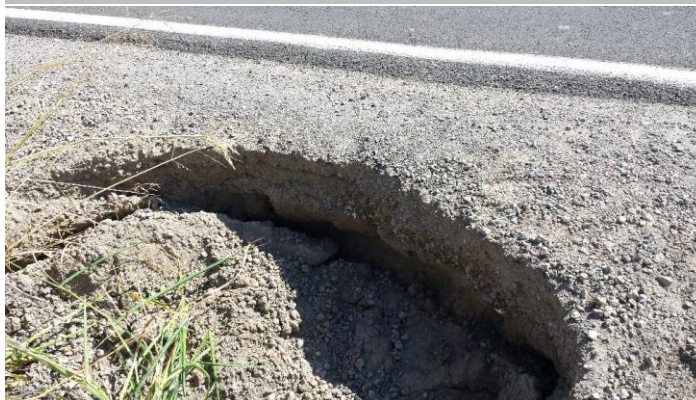
Photo 3 of 3 : UCIP_SP_2018_50007_74614.jpg

Slope damage within 2 feet of County Road.

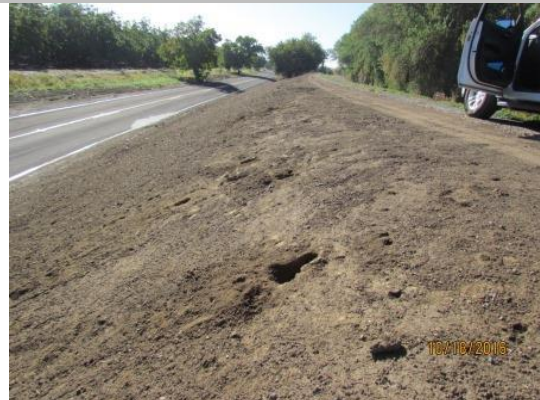
Photo 1 of 1 : SP_2018_RD0070_30_61_20180305_00010.jpg

View of the rodent holes along the landside slope.

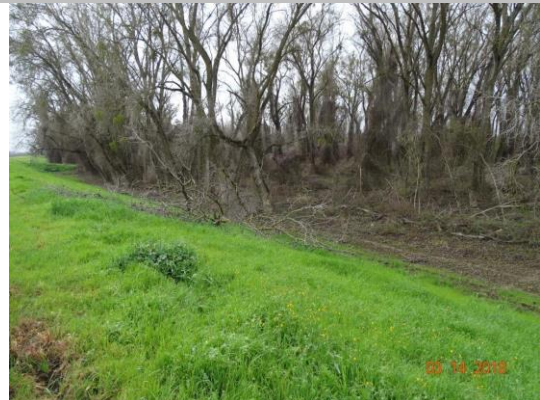
Photo 1 of 1 : SP_2018_RD0070_30_48_20180402_00128.jpg

View of the tree along the waterside slope and oe

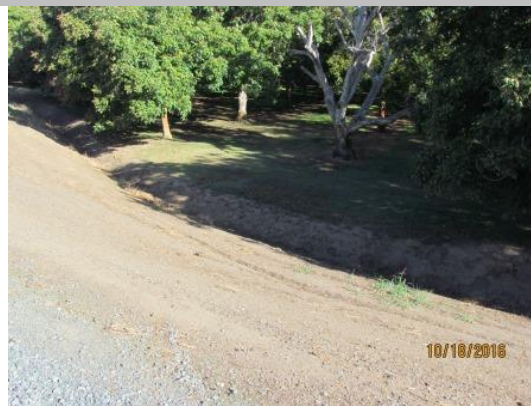
Photo 1 of 1 : SP_2018_RD0070_30_65_20180305_00012.jpg

View of a ditch along the landside toe.

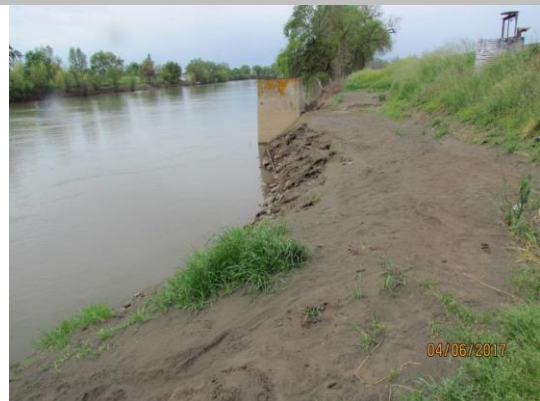
Photo 1 of 1 : SP_2018_RD0070_30_72_20180305_00015.jpg

View of the erosion along the waterside slope.
